# Caistor on the Wolds, Lincolnshire,

Provisional Survey of the Roman Walls, 2nd May, 2014

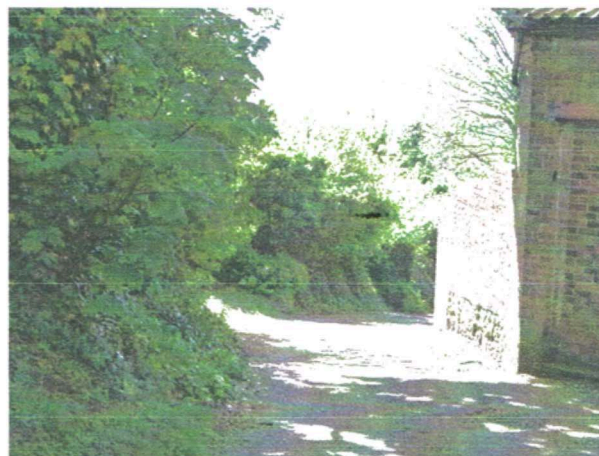
**Wall on Castle Hill forming part of the boundary of the Grammar School. (Rahtz A)**

Coursed blocks of rectangular stone forming a short section of wall. The width seems correct for the Roman wall but, at this point, the section, not the face of the wall should be seen and there is no sign of a rubble core. Across the road from this wall there are stones in the earth bank which might represent part of the wall.

*'A A modern wall on the east side of Church Lane (?) exhibits in 17 ft. of its length good dressed stone blocks in its lowest 2 ft. that were probably derived from the Roman wall, which should cross Church Lane hereabouts. The bank on the opposite side of the lane is also revetted with stone for some distance below this point.'*

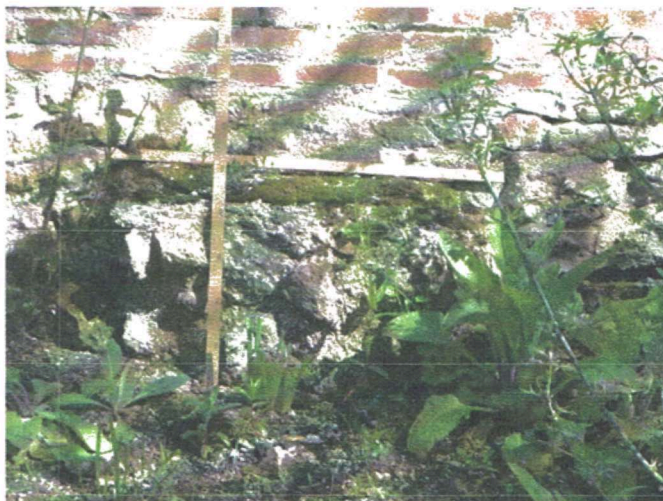
**Grounds of Caistor Grammar School (Rahtz B)**

Little to be seen but at one point a block of mortar and masonry suggests the presence of the wall or a bastion.

*B 'At the west end of the Grammar School grounds the line of the wall is marked by a mass of hard mortared rubble core several feet in length, similar to that of Cooper's Bastion; this is the piece noted by Richmond and Corder in 1946. It lies under ivy on the slope below a brick and stone wall which delimits the change in level of some 10 ft. at this point, which can be followed back to point A as the upper of a series of artificial terraces in the garden of Grove House. The concrete cannot be traced at any other point under the ivy in this area, and its differential survival at this point suggests the possibility that it may be a fragment of a bastion. It may well have been the fragment of wall seen 'behind the school-house in the pastures' by Stukeley.'*

grounds) we have what are likely to be the remains of the wall's rubble core. Limited excavations in these areas would be useful to resolve their nature and that of surrounding deposits.

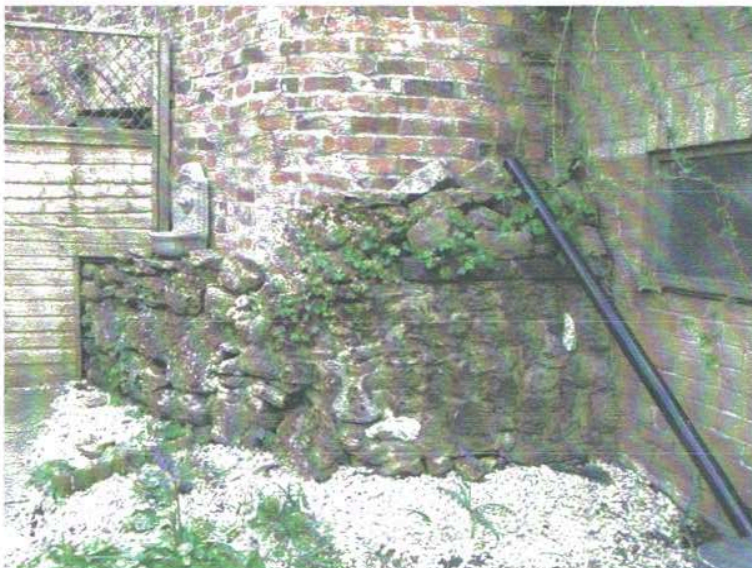
#### Chapel Street, 'North Bastion'

Irregularly laid coarse masonry, some blocks rectangular, forming the bastion, nothing to suggest that it was Roman although the location and its curving line supports this interpretation.

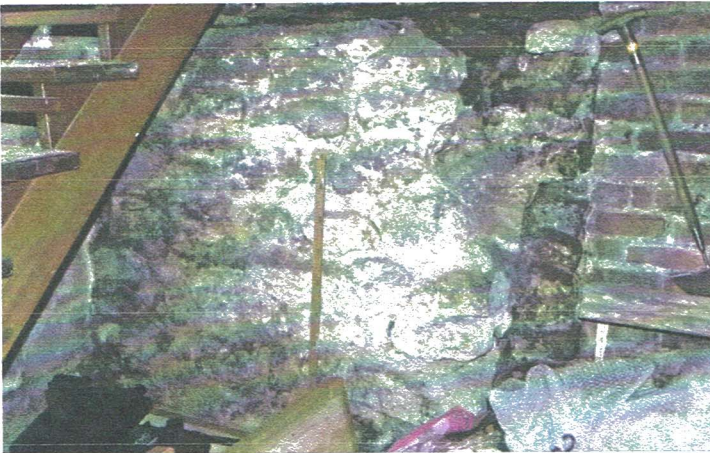
Rahtz, 1959, G, Detail of North Bastion

The wall section in an adjacent outbuilding is better coursed with more rectangular stones but it lacks any features that could confirm a Roman date. It is, however, difficult to see what other role it could have fulfilled and it is likely to be a relic of earlier activity.

G *This is the North Bastion, provisionally thus named for the first time, and not previously noted (pi. xxxv). The west side of the bastion is destroyed, but its east side, and the Roman wall-face continuing eastwards, survive for several courses. The bastion is first seen in the back wall of a row of garages 6 ft. west of their east end; here it survives to a height of 5 ft. above present floor level, and projects slightly from the brick wall of which it is a continuation. Dr. Corder and Mr. Sheppard Frere considered it to be wholly of Roman work here. Emerging from the garages the outer face of the bastion continues for a further 5 ft. then turns inwards at an angle of some 110 degrees, now 4 ft. high. The next 9 ft. on this new alignment is rebuilt in very rough work, but the apparently original coursing is then resumed until it reaches the main wall, with which it appears to be bonded. The bastion as thus defined is partly original, and is capped by modern brickwork which follows its line. Inside the bastion the ground level is some 3—4 ft. higher than that outside, and forms an annexe to one of the gardens of Chapel Street.*

*The main wall alignment, of good dressed Roman work for at least its three lowest courses, continues for a further 13! ft., partly behind an outhouse, before it is cut by brickwork.*

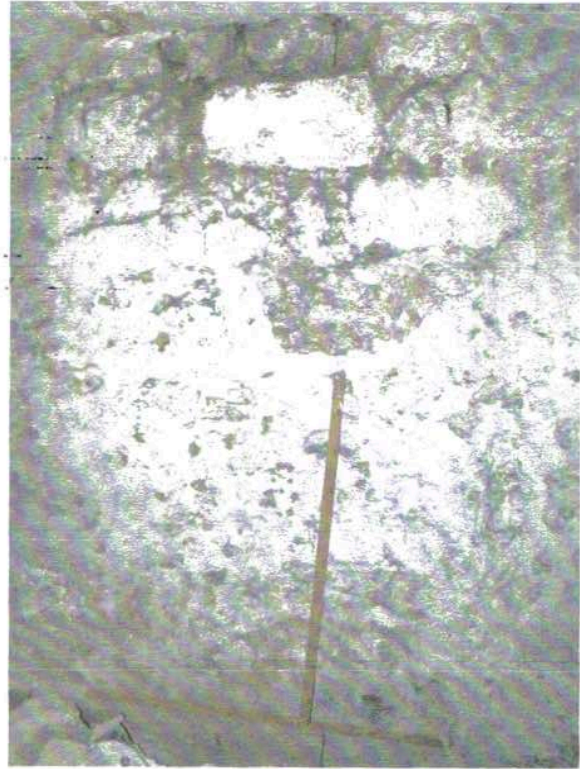
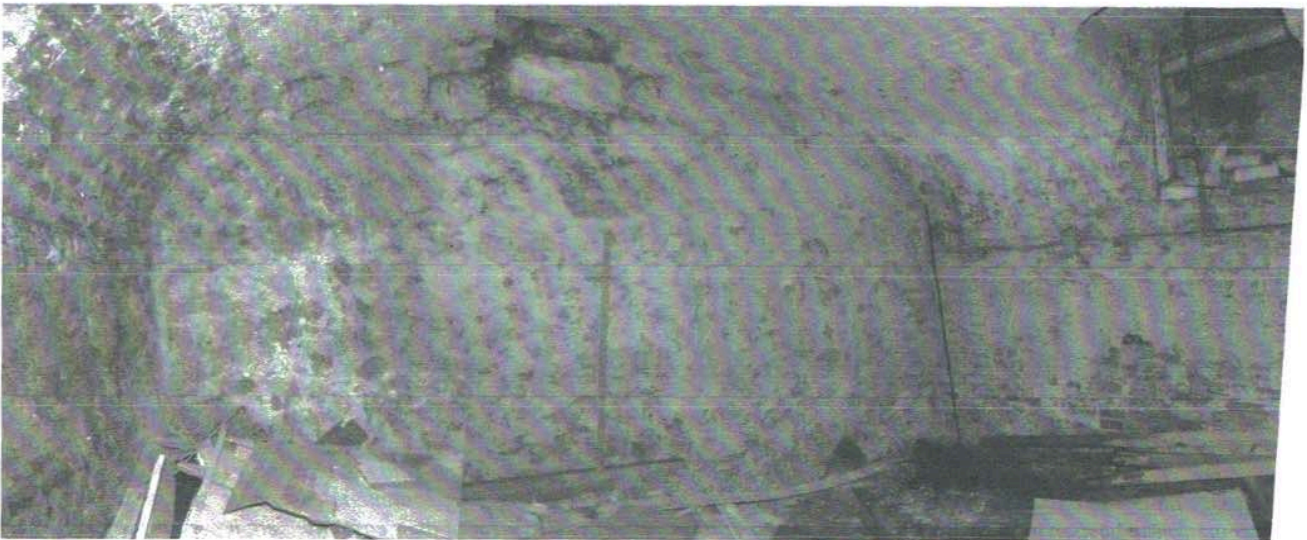
View of the end wall of the cellar of the pizza take away.

Large, vaulted brick cellar the end wall of which is made up of coursed blocks of masonry, the details of which are hidden by rendering. In the centre of this wall are the truncated remains of a door or window, blocked off with large, rectangular stones. Some concerns were felt over the Roman dating of this walling. It is more than 1.5m high and appears to consist of laid stone from top to bottom. Even with the rise in ground levels since the Roman period it might have been expected that we should be seeing traces of the wall's foundations at this level. However, it is clear that it predates the cellar, the blocked door opening could have fulfilled no role in the cellar and must be a relic of previous use. Whether or not a window would have been appropriate in a Roman defensive wall is open to question particularly if the walls were as thick as those

*'K The Co-operative Society's premises have a long cellar under the greater part of their Market Square frontage, and most of this is of brickwork, but the rear wall is entirely of large dressed stone blocks. If this was the front face of the wall, it would make too sharp an angle for the north east corner of the wall; it may be rebuilt work, or associated with a bastion or corner tower. It should be noted that the present west side of the Market square is in two alignments; if the Roman east wall is straight, as we have suggested, it follows the alignment of those frontages south of Bank Lane, to judge by the alignment at (point) L. Some cracks in masonry may be seen at the back of adjoining properties, but none of the shops between (point) K and Bank Lane itself has cellars extending far enough back to reach the line of the wall, and all of brick. Bank Lane itself has a distinct hump in its surface west of its junction with Market Square, and the hump in this case is probably the remains of the wall and gatehouses.'*

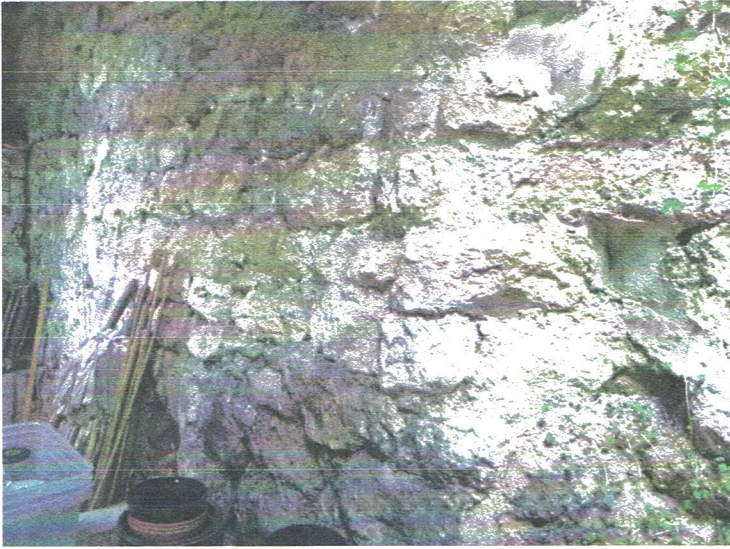
## Rear of a cottage off Plough Hill (Probably Rahtz O)

Large section of wall at the back of an outhouse built up against the terraced churchyard wall. Coarse masonry, some rectangular stones, wall appears to have been rendered. Nothing that would support a Roman date. The location of this wall, which retains the terrace above, might suggest that it is of post-Roman date. This could only be tested by excavation.

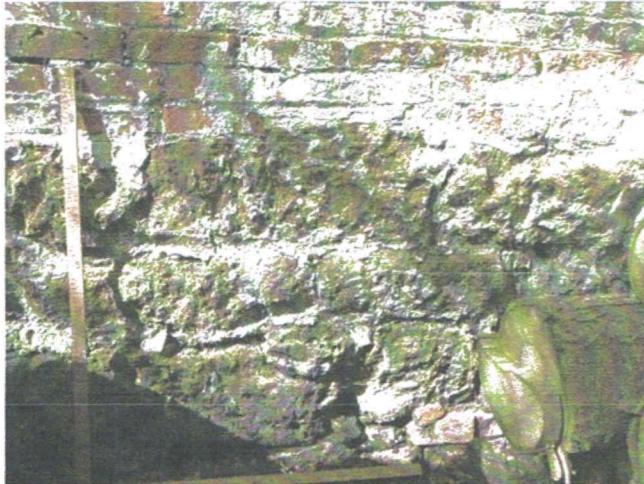
Possible walling

Section of coursed masonry walling, large stones, rectangular, nothing to confirm a Roman date. Near to this was a lump of stone and mortar which looks like the core of the Roman wall or of a bastion.

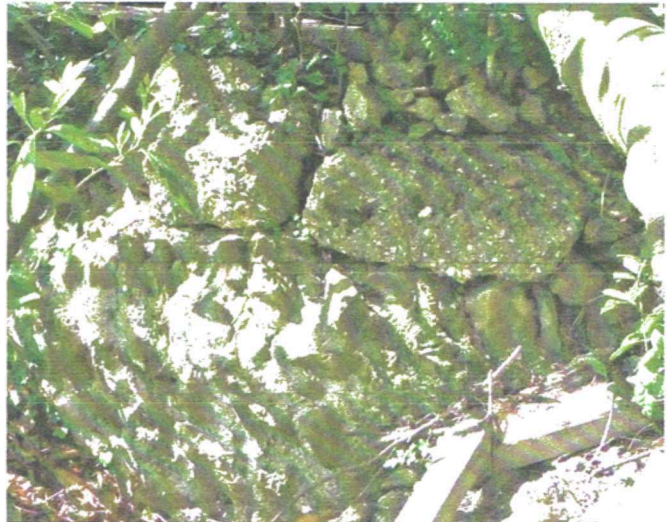
Stone and concrete possibly representing the core of a bastion.

*'U West of this building a rough line of rebuilt stonework forms the southern edge of a raised platform constructed within living memory; this continues the alignment at (point) R for a further 12.5 ft., and then, in a garden, a ragged mass of hard mortared rubble core projects about two feet. The stones composing it are roughly pitched, of rather smaller stone than those in Cooper's Bastion, but the mortar is similarly hard and cream-coloured (see p. 185). The survival of this awkward obstacle, and its relation to the alignment of wall-face at T, makes it very probable that this is another bastion, now named Williams's Bastion, 100 ft. from the previous one at S. It is 14 ft. wide as it exists at present. Beyond it to the west, the raised platform edge extends a further 2 ft., then the line of wall is wholly destroyed by a large house and its surrounding area cut back into the slope.*

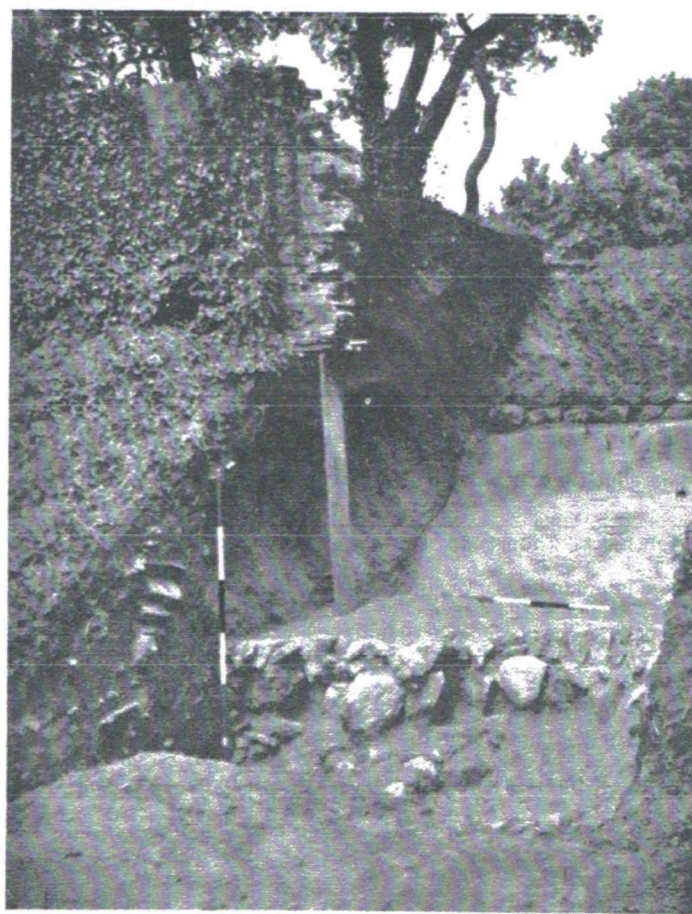
The 1959 section of Caistor's Roman defences. It is interesting to note that Health and Safety was a prime consideration.
